**STRUCTURES REPORT 375**

**THE STRENGTH OF OCCUPANT RESTRAINT**  
**SYSTEMS IN LIGHT AIRCRAFT**  
**— AN EXPERIMENTAL EVALUATION**

by  
**S. R. SARRAILHE**

FEBRUARY 1979

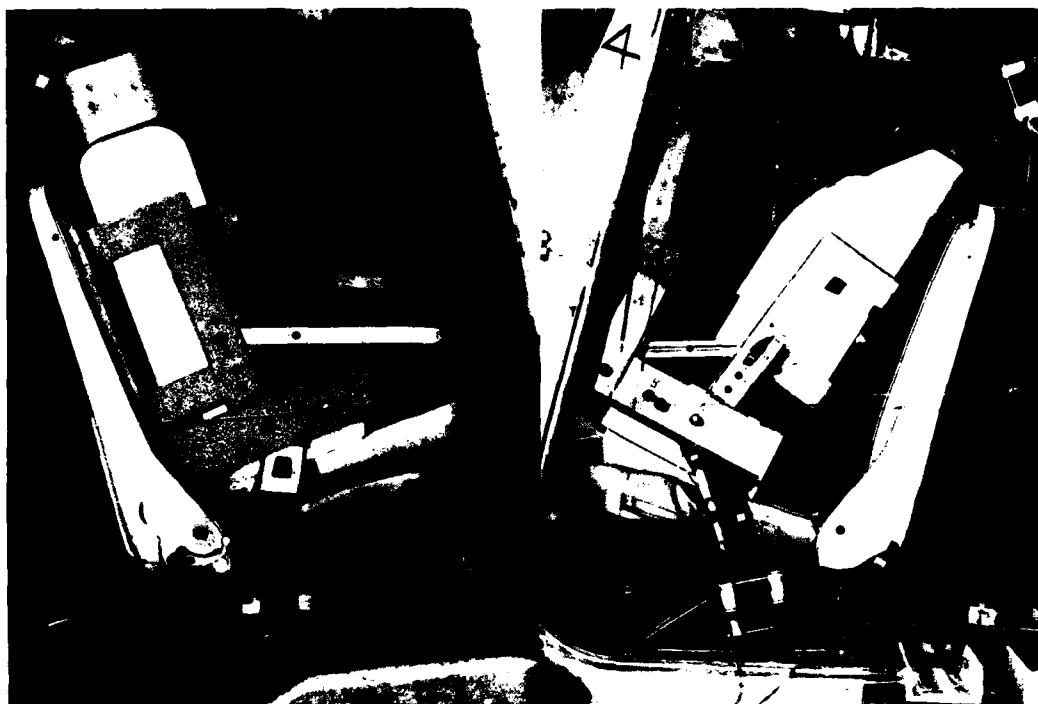
FIG. 1. PIVOTED BODY BLOCK INSTALLED AND UNDER LOAD IN A LAP SASH RESTRAINT.

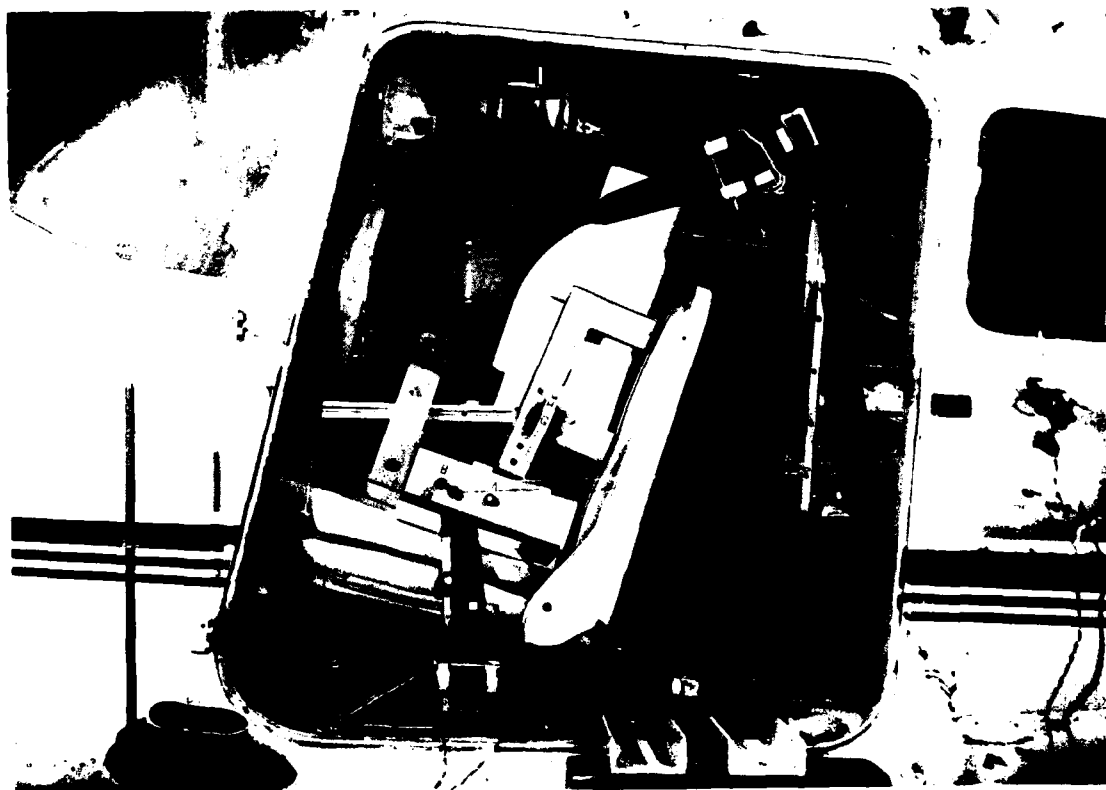
FIG. 12. LAP SASH RESTRAINT SYSTEM TEST IN THE CABIN OF AIRCRAFT "C"

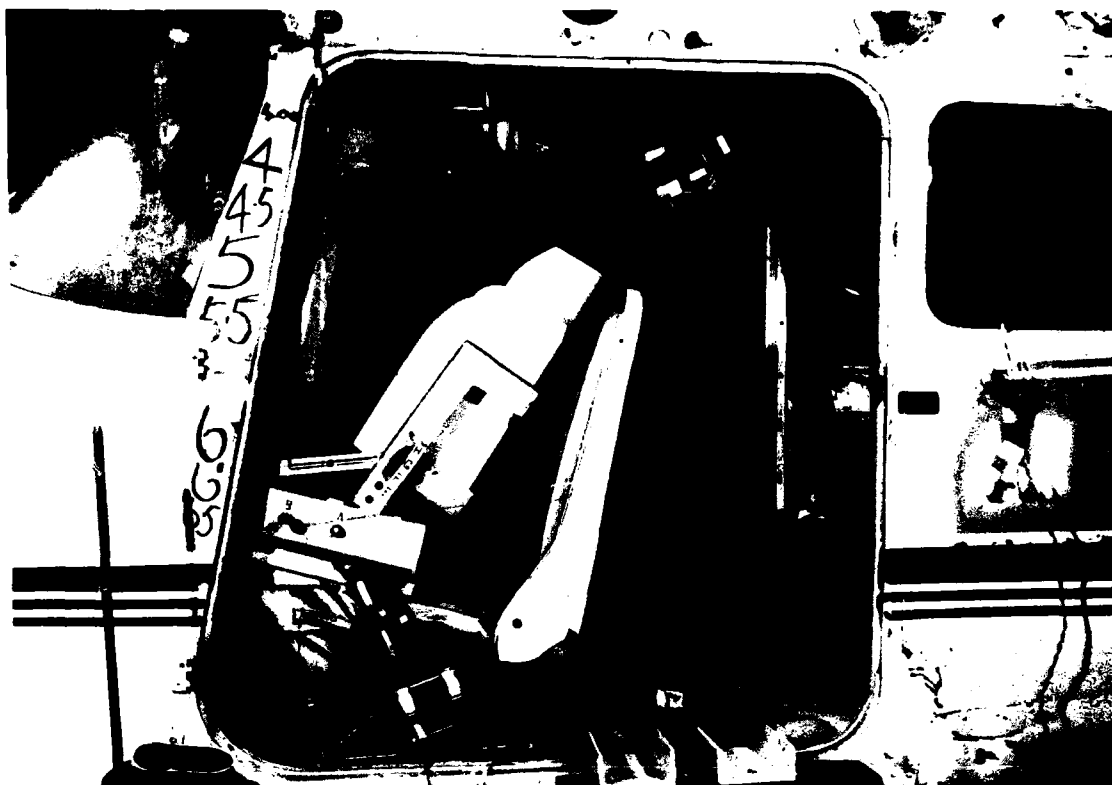
FIG. 14. RESTRAINT SYSTEM UNDER LOAD OF 8kN IN AIRCRAFT 'C'

The condition just before this happened is shown on Figure 14. Body block load was 8 kN and the tensions in the inner and outer lap straps were 3 kN and 1.8 kN, respectively. Resolution of the applied load and strap tensions indicated a reaction between the dummy and seat of about 4 kN. The position and directions are indicated on Figure 15, where it is seen that most of the load would have been applied to the seat front cross bar.

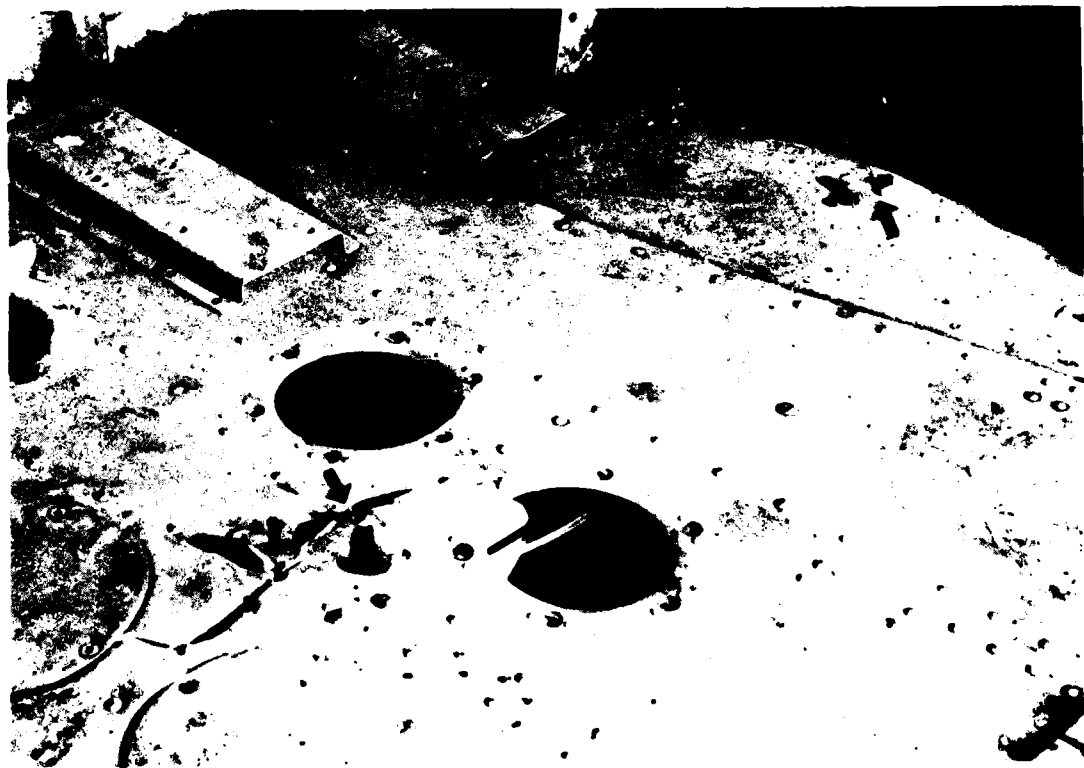
FIG. 21. FAILURE OF THE FLOOR AND THE PAIR OF INNER LAP STRAP ANCHORAGES (23kN) AND FAILURE OF THE OUTER ANCHORAGE (10kN) – BACK SEAT AIRCRAFT 'C'

The seat was removed and the inner anchorages tested by applying load directly to the two bolts. The load was applied in a forwards and upwards direction approximately 30° to the horizontal. The bolts withstood 21 kN with negligible deflection, but at 23 kN the floor panel split and resistance fell as the structure failed. The split is shown on Figure 21.

Tests on the rear seat assembly indicated that it could withstand forward forces of at least 10 kN acting on each of the occupants. The assembly was weakened by slotted holes in the foot of the seat, but these may have been cut after manufacture. It is very difficult to see or reach the rear seat mounting bolts and if the seat is removed frequently, to allow extra room for cargo, there would be strong temptation to omit some of the fastenings or to make them easier to fit. In normal use such omission would not be evident nor present a problem however in an emergency the strength would be deficient because under this loading the back bolts are needed to carry the greater part of the load.
